Severe Service Journal

Volume 9 Issue 2, April 2009

MIDWESTERN POWER PLANT USES CAV4 TRIM TO AVOID RECIRCULATION VALVE LEAKAGE PROBLEMS

DESIGN EHAZ VALVES WITH CARBIDE LINERS DELIVER RELIABILITY

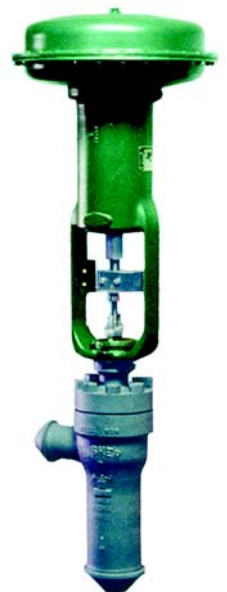
The CAV4 trim was designed specifically for feedpump recirculation applications. This solution incorporates four stages of anti-cavitation protection, a technique that prevents the formation of damaging cavitation at pressure drops up to 6000 psid.

A properly sized CAV4 valve prevents cavitation, and therefore the noise and vibration it causes, by directing flow through successively larger flow areas, with each causing a reduction in pressure. This "staging" of the overall pressure drop results in more than 90 percent of the total drop being taken in the first three stages where there is little danger of bubble formation. The last stage experiences a low inlet pressure and pressure drop.

The pressure staging together with the separation of shutoff and throttling locations within the CAV4 trim prevent seat erosion. The trim design does not allow significant pressure drop to be taken until the fluid is downstream of the seating surface. All clearance flow is subjected to a staged pressure drop.
